Effects of sodium hypochlorite on corrosion of the rotary nickel-titanium endodontic instruments – SEM analysis

Milica Jovanović-Medojević¹, Jelena Nešković¹, Marijana Popović-Bajić¹, Đorđe Stratimirović², Slavoljub Živković¹

¹University of Belgrade, School of Dental Medicine, Department for Restorative Dentistry and Endodontics, Belgrade, Serbia;

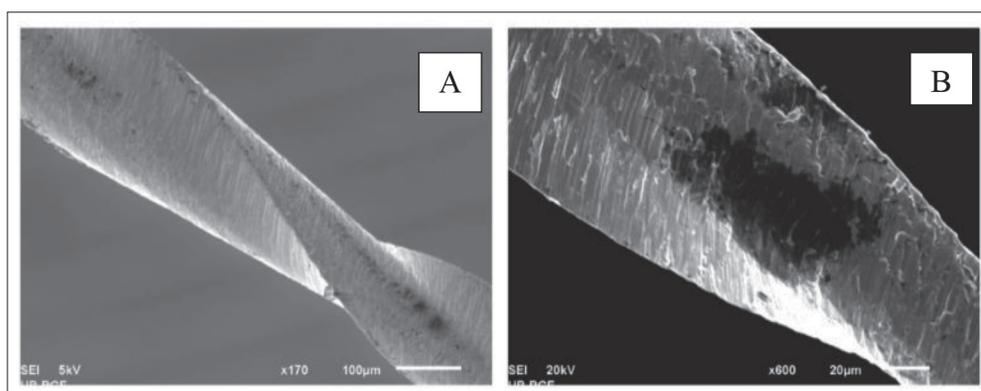
Figure 1. Spin echo image of the new Mtwo instrument (10/0.4): A – surface of the middle third on which the presence of corrosion is observed (170 ×); B – detail from the previous image at higher magnification (600 ×)

In new Ni-Ti instruments, corrosion was observed in 5.5% of K3 system instruments (apical and middle segment), in 5.5% of Mtwo instruments (apical third) (Figure 1) and in 11.1% of ProTaper Universal system instruments (apical and middle third). Corrosion was not observed on the new sets of HyFlex and BioRaCe instruments (Table 2).

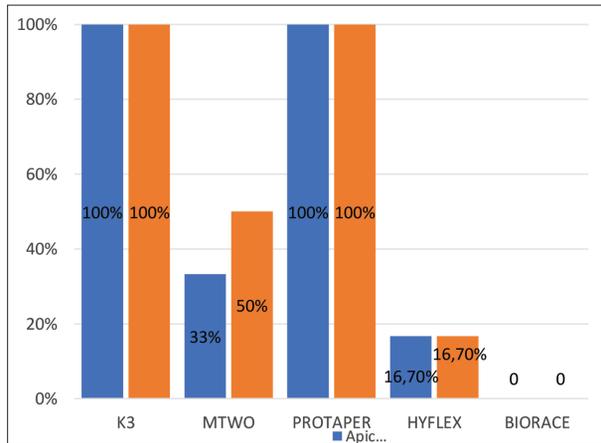
Figure 2. Prevalence of corrosion on Ni-Ti instruments after instrumentation of disinfection and sterilization in the canals of the first group; letters (a or b) indicate no statistically differences ($p > 0.05$)

In the first group, corrosion was observed on all instruments K3, ProTaper Universal and HyFlex systems (apical and middle third), and in Mtwo systems on 16.7% of instruments (apical and middle third). Corrosion was not observed in BioRaCe instruments. A statistically significant difference was observed between the K3, ProTaper Universal and HyFlex systems compared to the Mtwo and BioRaCe systems of the first experimental group ($p < 0.05$) (Table 3, Figure 2).

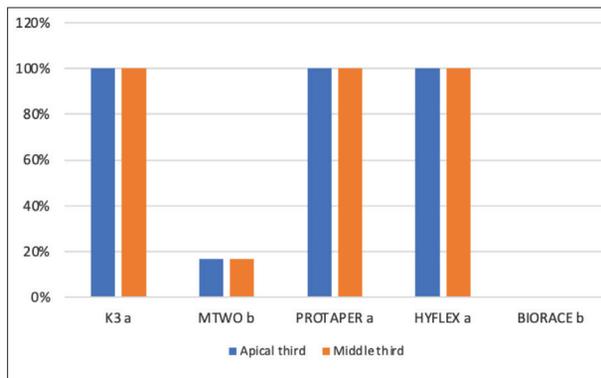
Figure 3. Corrosion prevalence on Ni-Ti instruments after instrumentation, disinfection and sterilization in the channels of the second group; letters (a or b) indicate no statistically differences ($p > 0.05$)

In the second experimental group, corrosion was observed on all analyzed Ni-Ti instruments K3 (Figure 3) and ProTaper Universal system (apical and middle third), in HyFlex set on 16.7% of instruments (apical and middle third), and in Mtwo set instruments, to 33.3% of instruments in the apical segment and 50% in the middle third. No corrosion was observed on BioRaCe instruments. A statistically significant difference was observed between K3 and ProTaper Universal systems compared to Mtwo, HyFlex and BioRaCe system ($p < 0.05$) (Table 3, Figure 4).

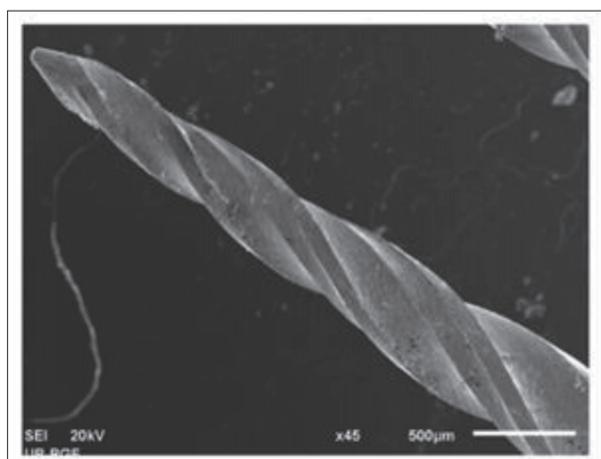
Figure 4. Spin echo image K3 instrument (25–0.08), second experimental group (corrosion on the apical third) (45 ×)

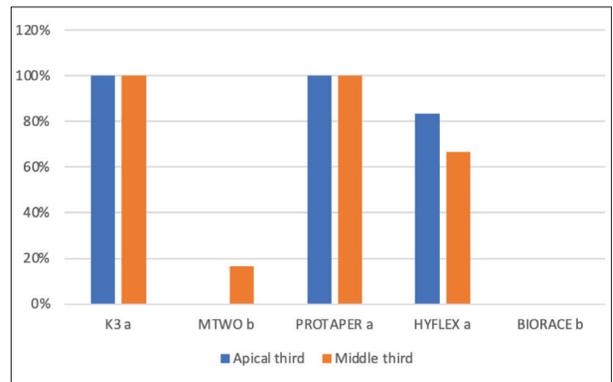
Figure 5. Prevalence of corrosion by Ni-Ti instruments after instrumentation, disinfection and sterilization of third group; letters (a or b) indicate no statistically differences ($p > 0.05$)

In the third experimental group, corrosion was observed on all analyzed Ni-Ti instruments K3 and ProTaper Universal system (apical and middle third), in 83.3% of HyFlex set instruments in the apical and 66.7% in the

middle segment (Figure 5). In the Mtwo set, corrosion was observed only in the middle third in 16.7% of the instruments. A statistically significant difference in the occurrence of corrosion was observed between K3, ProTaper Universal and HyFlex systems in relation to Mtwo and BioRaCe system ($p < 0.05$) (Table 3, Figure 6).

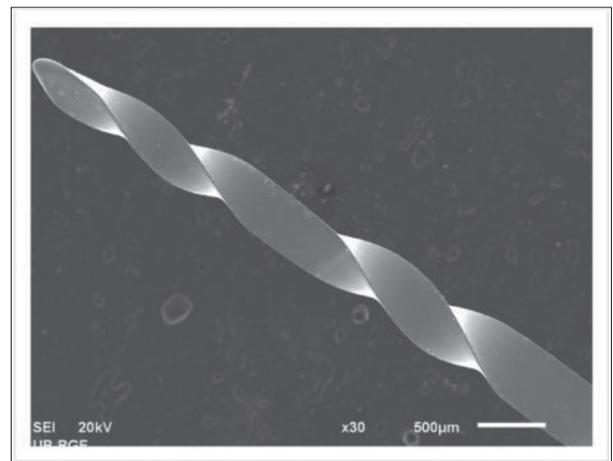
Figure 6. Spin echo image BioRaCe instrument no. 4 without incorporation and corrosion (30 ×)
