Case report / Приказ болесника

Breast implant rupture 37 years after breast augmentation

University of Belgrade, Faculty of Medicine, University Clinical Center of Serbia, Clinic for Burns,
Plastic and Reconstructive Surgery, Belgrade, Serbia

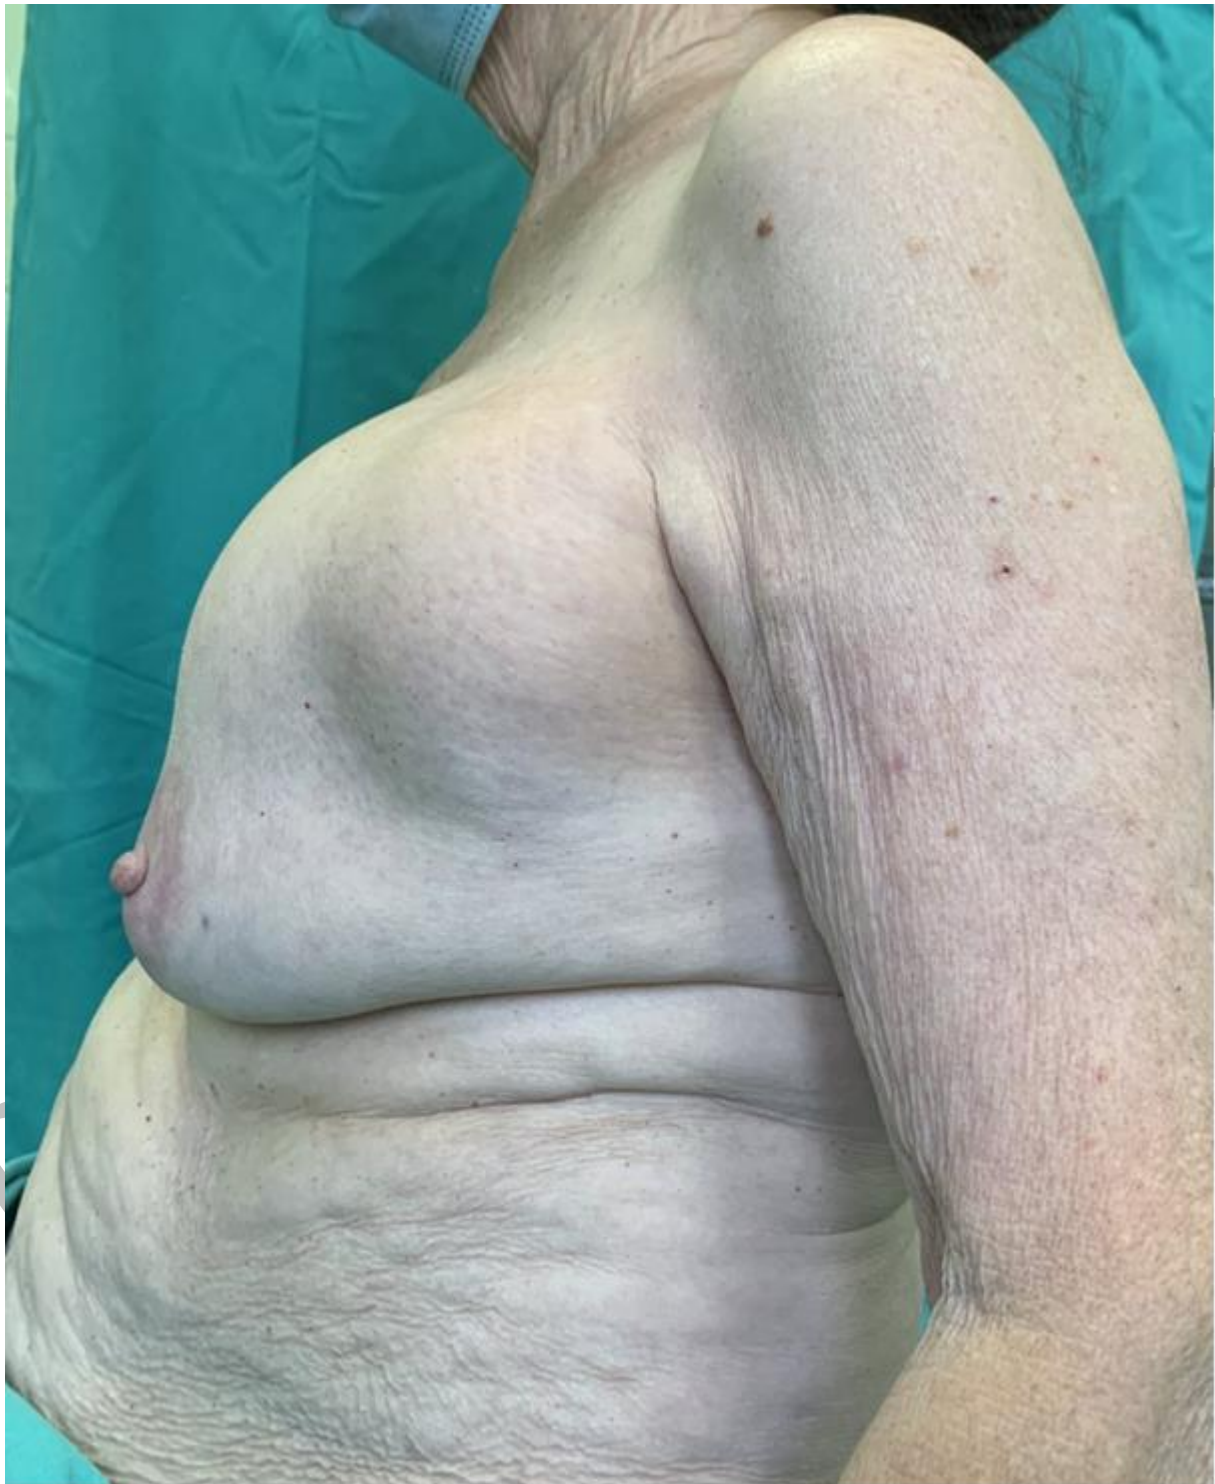
Figure 2. In the upper left quadrant, there was a tumefaction of about 5×5 cm, insensitive to palpation, partially fixated, of hard consistency, without signs of inflammation present

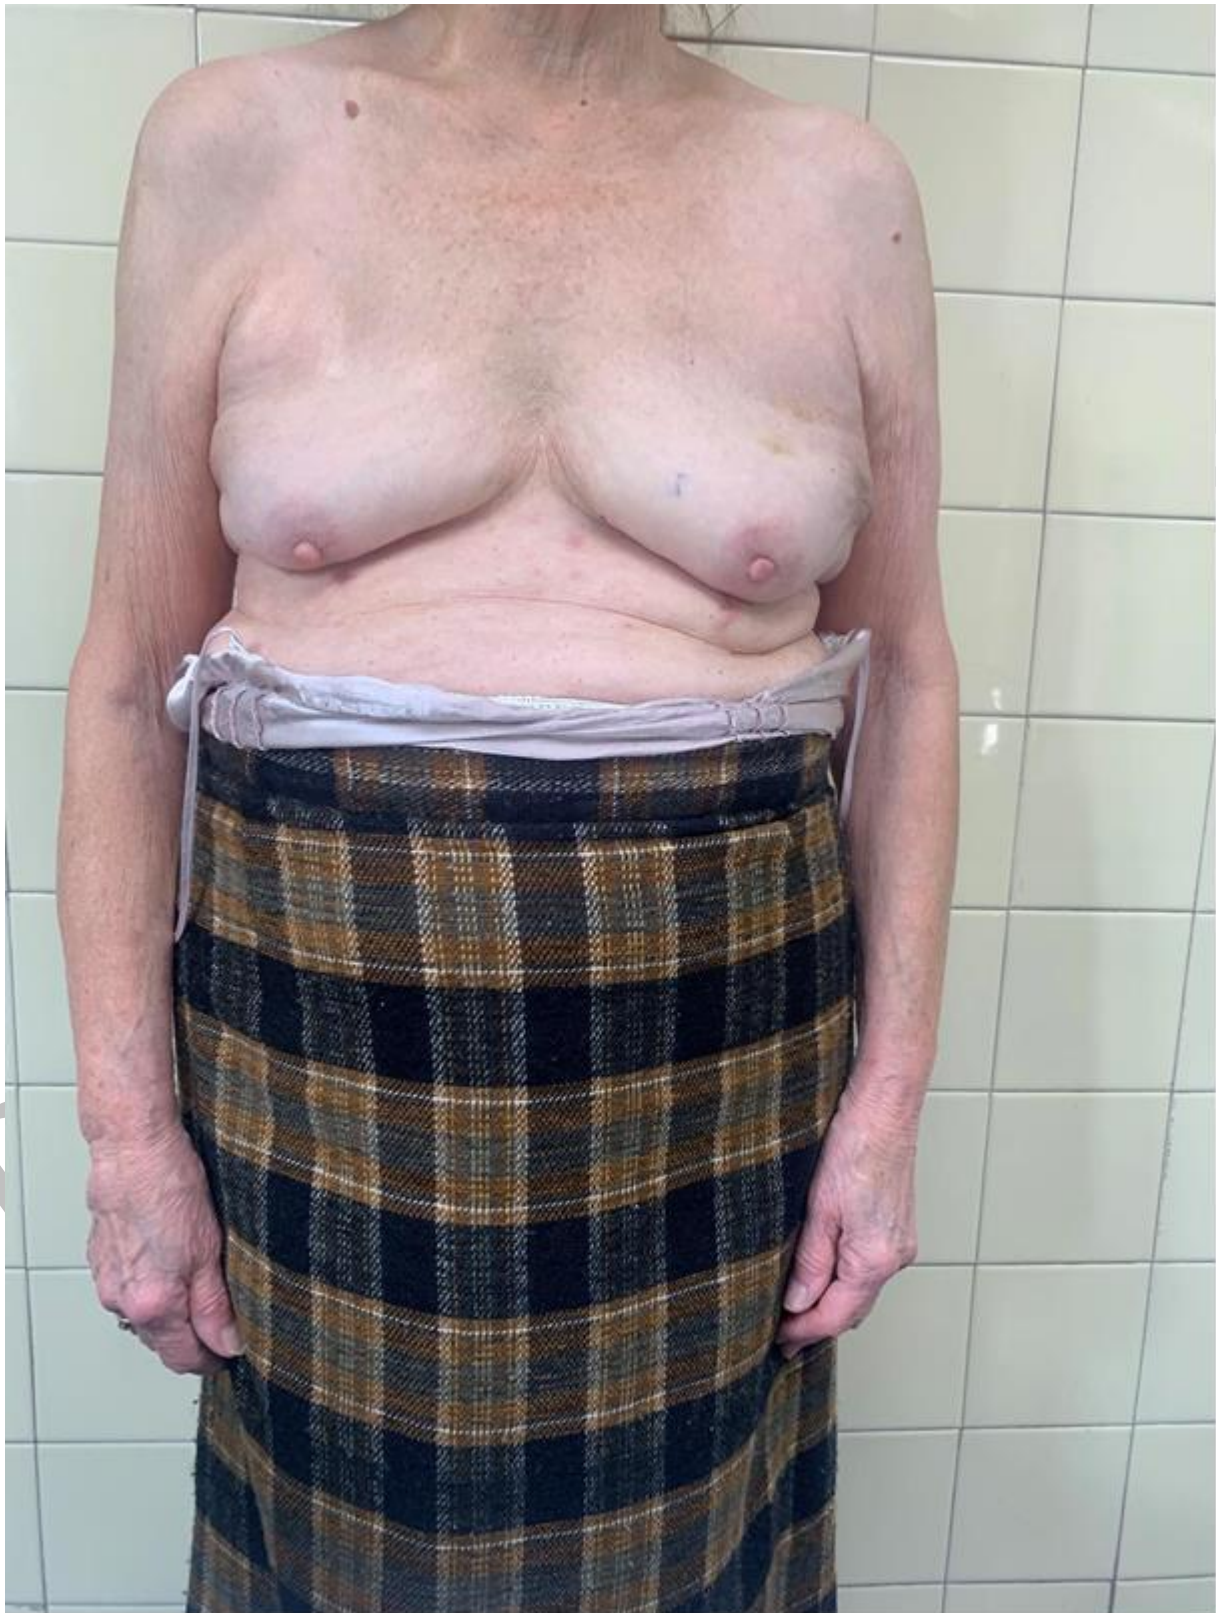
Figure 4. Postoperative follow-up

and presence of tumefaction in the area of her left breast. Her medical history revealed that she had breast implants placed in 1983 for augmentation purposes. She said that she had fell 5 years previously and injured her chest on the left. Ever since, she could feel a tumefaction of about 1 x 1 cm that had gradually grew. Clinical examination revealed breast asymmetry (Figure 1.). In the upper left quadrant, there was a tumefaction of about 5 x 5 cm, insensitive to palpation, partially fixated, of hard consistency, without signs of inflammation present (Figure 2.). Mammography suggested signs of herniation of the implant towards the axillary extension, i.e. differential diagnosis suggested a rupture. The right implant also had uneven edges. Ultrasound scan revealed blurred lines of the capsule in the external quadrant of the left breast above which there was a hyperechogenic area that was suggestive of imbibition of the surrounding tissue due to extravasation of the implant filling. In the upper external quadrant of the left breast, there was a non-homogenous area with mildly affected tissue architecture, 26 x 14 mm, along the implant itself. Towards the axillary extension of the left breast an oval discrete structure, about 68x46mm, suggestive of herniated part of the implant is seen. On the basis of mammography, echotomography and clinical examination surgical treatment was indicated. Both implants, both connective tissue capsules and silicone imbibed surrounding tissue were removed (Figure 3.). The tissue was sent for histopathological examination. The results verified the presence of hyalinized capsule with calcifications and multinuclear giant cells filled with polarized foreign matter (silicone). On follow-up patient was overall satisfied with the outcome (Figure 4.).
