CASE REPORT / ПРИКАЗ БОЛЕСНИКА

Developmental hypomineralization of the enamel of the first permanent and the second deciduous molars – report of two cases

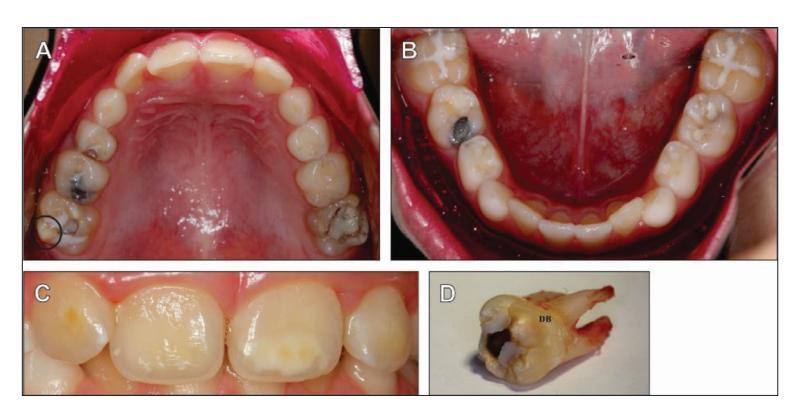
Figure 1. A) Upper dental arch of the nine-year-old boy with severely affected enamel of both upper first permanent molars (FPMs); on tooth 16, a hypomineralized disto-buccal tooth cusp (present in Figure 3) is marked with a circle; B) lower dental arch with healthy FPMs without hypomineralizational aberration; C) molar-incisor hypomineralization-affected permanent upper incisors; D) the extracted upper right FPM (tooth 16) with posteruptive enamel breakdown due to exceptionally poor mineralization of the enamel; DB – disto-buccal side of the tooth

A nine-year-old boy was referred to the University Dental Clinic due to complications related to the endodontic treatment of a nonvital upper left FPM (tooth 26). The patient was otherwise healthy, with no metabolic, endocrine or any other systemic disease. The likelihood of dental fluorosis was excluded. The clinical status is described under Figure 1. The final interdisciplinary treatment plan was agreed upon. Based

on the results of the analysis of occlusal relations, the poor long-term prognosis of both upper FPMs and a possible midline shift, the decision to extract both upper FPMs was made. Tooth 16 (Figure 1C) was analyzed as described below.

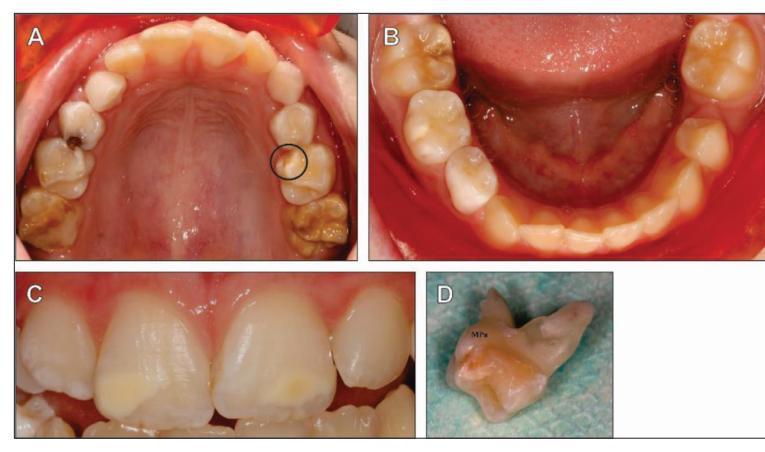
Figure 2. A) Nine-year-old girl with mixed dentition and severely affected enamel of both upper first permanent molars (FPMs); the right FPM with an atypical restoration and the left FPM (tooth 26) with posteruptive enamel breakdown; on tooth 65, a hypomineralized mesio-palatal tooth cusp (present in Figure 5) is marked with a circle; B) on the lower right FPM (tooth 46), insufficiently mineralized enamel is sharply demarcated from a normally developed enamel; deciduous molars have chalky-whitish patches (teeth 54, 55, 65, 84, and 85); two deciduous molars are missing due to premature extractions; C) both upper central incisors are also molar-incisor hypomineralization-affected; D) the hypomineralized upper left second deciduous molar (tooth 65), extracted due to recurrent spontaneous pulpitic pain and further histologically examined; MPa – mesio-palatal side of the tooth

The second patient, a nine-year-old girl, was referred to the clinic due to severe hypersensitivity of the upper right FPM (tooth 16). Her medical history also reported no systemic disease or medications (e.g., antibiotics, fluorides). The clinical status is described under Figure 2.

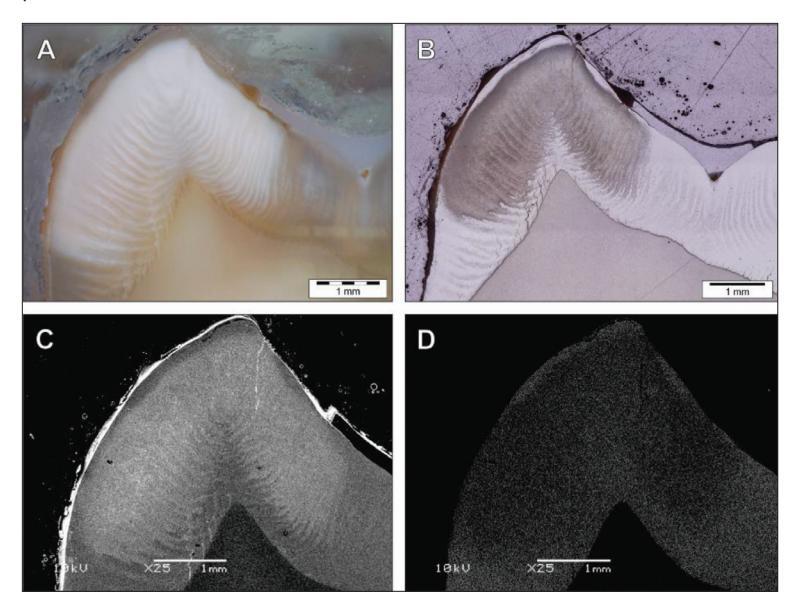
Figure 3. A) Stereo microscopy and B) light microscopy of the longitudinally cut upper-right first permanent molar (tooth 16) crown showed clearly less mineralized enamel through most of its thickness of an molar-incisor hypomineralization-affected disto-buccal tooth cusp; between the porous and normally mineralized enamel, a clear delineation is visible; C, D) the same distobuccal tooth cusp observed with a scanning electron microscope; C) on the secondary electron image directly below the surface, a thin layer (of some ten micrometers in its width) of appropriately mineralized enamel and a ribbon of normally mineralized enamel near the dento-enamel junction are visible; hypomineralized areas of enamel are brighter compared to apparently normal enamel; D) on the backscattered electron image, hypomineralized areas of the enamel appear darker, and the borders are not as distinct as on the secondary electron image

In both tooth samples, the thickness of the enamel was normal. However, both samples had areas with developmentary hypomineralization enamel, which extended almost all the way from the dento-enamel junction (DEJ) to the tooth surface (Figures 3 A-D and 5 A-C). A thin layer of unaffected enamel on the tooth surface was lined with a normal aprismatic layer, while the majority of the bulk of the enamel was altered to varying extents. Under the LM, the hypomineralization areas appeared darker. As shown in Figures 3 and 5, the surface of the MIH-affected tooth cusp could be preserved. In parts with regular development, the prisms were normal and well defined (Figures 4A and 6A). In the aberrant part of the enamel, the microstructure was deficient in most of its thickness, with prisms poorly defined and inadequately mineralized (Figures 4B and 6B). In areas with poorly formed or even unrecognizable enamel prisms, different levels of porosity is anticipated, as well as residual organic material which had not been removed during amelogenesis. On etched samples, the difference between the normally formed enamel (with a well-formed etching pattern) and the hypomineralized enamel (with prism boundaries not clearly delineated) was even more apparent. The microstructure of the hypomineralized enamel showed poorer organization of the hydroxyapatite crystals within the prisms and wider sheath regions.

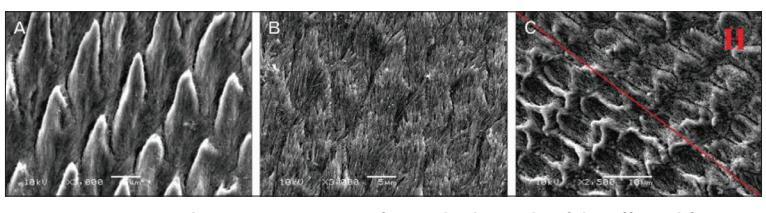
Figure 4. Scanning electron microscopy of an etched sample of the affected first permanent molar presenting A) normal and B) aberrant areas of the enamel; A) on parts where the course of amelogenesis was normal, the appearance of enamel prisms is typical, with nicely arranged enamel prisms; hydroxylapatite crystals are closely packed and correctly oriented (secondary electron image – SEI, ×3000); B) conversely, on hypomineralized parts of the enamel, enamel prisms are less prominent; hydroxylapatite crystals are not packed together so tightly (SEI, ×3000); C) image presents the sharp delineation (delimited with red line) between the porous [i.e., hypomineralized, marked with H, and normally mineralized enamel (SEI, ×2500)]

In the FPM and the SDM, a clear demarcation between the normally developed and the developmentally affected enamel was observed under SM, LM, and SEM (Figures 4C and 6C). Furthermore, in both samples, hypomineralized areas seemed to follow the incremental lines of Retzius. In the FPM, as well as in the SDM, no changes in the structure of the dentine underneath the hypomineralized enamel was observable.

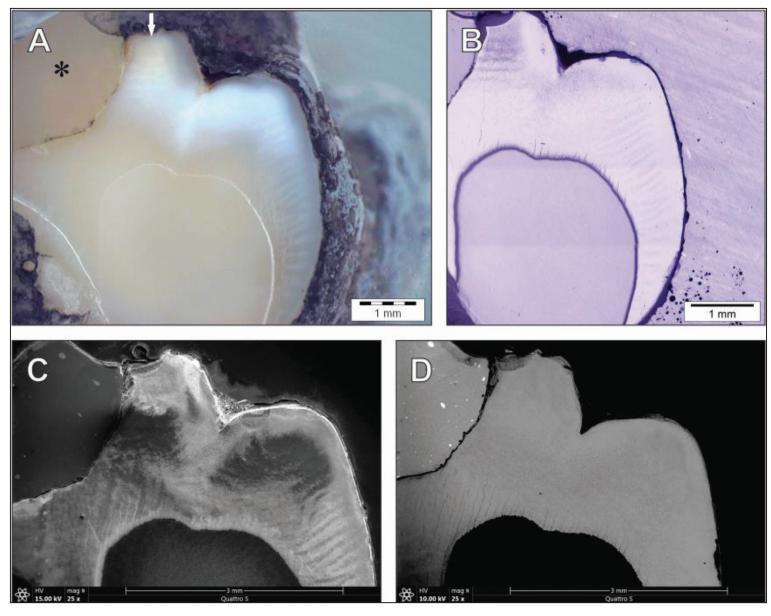
Figure 5. Longitudinally cut upper-left second deciduous molar (tooth 65), observed as an unetched specimen with A) stereo microscopy and B) light microscopy, revealed insufficiently mineralized enamel through the most of enamel thickness of the affected mesio-palatal tooth cusp; note a clear delineation between the insufficiently and normally mineralized enamel; the majority of the opacity is whitish, more porous hypomineralized enamel adjacent to the filling (marked with an asterisk) is cream-colored (indicated by an arrow); the same tooth cusp, observed with a scanning electron microscope, after previous etching for 20 seconds, shows C) two layers of normally mineralized enamel: a layer directly below the enamel surface and a layer near the DEJ observed in the first permanent molars (secondary electron image); D) observation with backscattered electrons exposed no obvious differences in the enamel structure

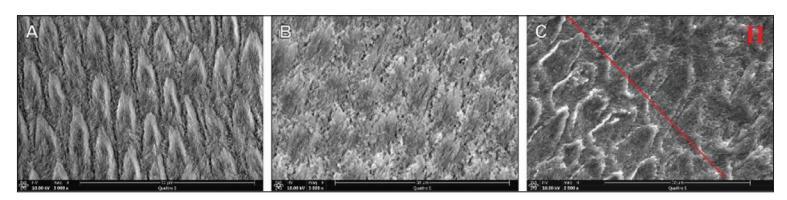
Figure 6. Scanning electron microscopy of the etched sample of the affected second deciduous molar present A) typical etching pattern of properly arranged and well-formed enamel prisms in an area with normally developed enamel; hydroxylapatite crystals are closely packed and correctly oriented (secondary electron image – SEI, ×3000); B) conversely, in the cream-colored area of the enamel, the prisms are disorganized (SEI, ×3000); C) the red line on the image shows clear demarcation in the histological structure of porous (H) and normally mineralized enamel (SEI, ×2500); H – hypomineralized enamel
